Seminole Nation Historical Society

# **Interior Improvements and Facility Upgrades to the Seminole Nation Museum**

*Report to the Board of Directors  
August 23, 2011*

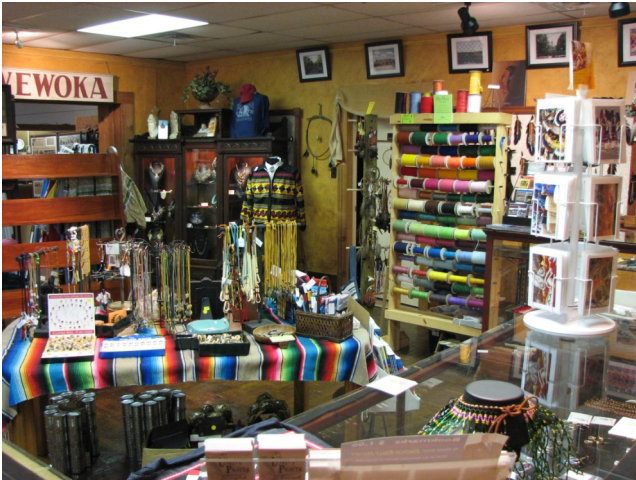
[Left] In its original state, the gift shop was unattractive and overcrowded, making it difficult for shoppers to discern what merchandise was available.

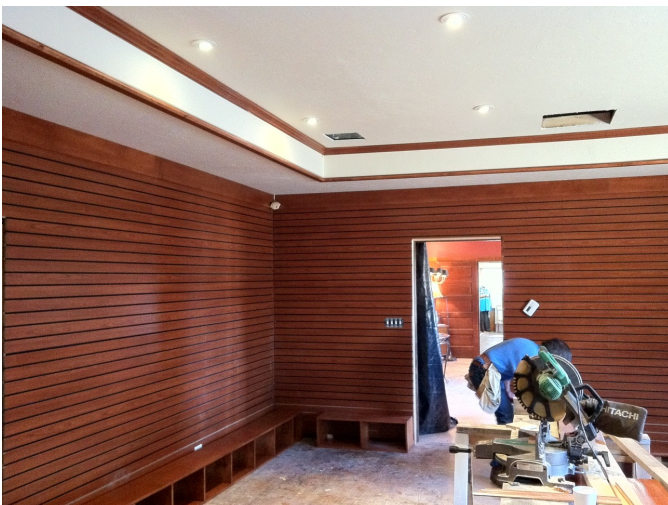
[Above] Aaron Johnson of Thomas Construction works to skim-coat the new drywall tray ceiling. The raised field of the ceiling will contain 16 low-voltage halogen lights, while the lower deck will contain low-voltage track lighting surrounding the room.

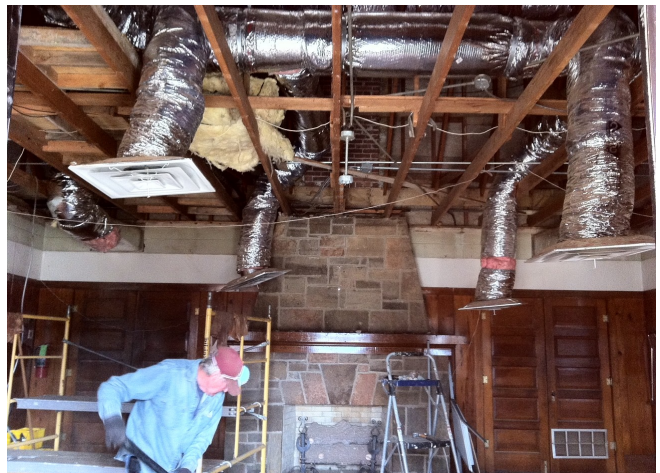
[Left] Although perfectly serviceable, the entryway was dimly lit, had no focal point and did not have a grand and welcoming enough appearance for visitors. The tile ceiling was extensively damaged from numerous roof leaks. Also, the tile floor was releasing from its substrate and cracking, presenting a trip hazard.

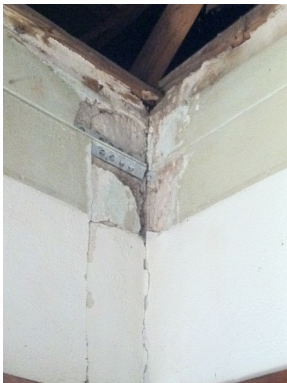
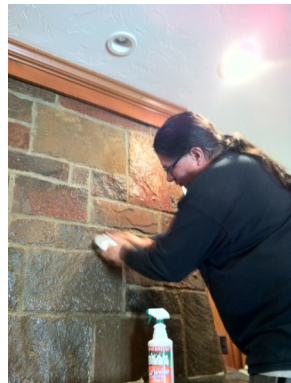
[Above] The entry space was stripped, leaving only the fireplace and the original pine wall paneling. Elevating the height of the ceiling made the fireplace more imposing. [Far Left] The cracks in this plaster were caused by an improperly shunted leak over the front porch. The leak was repaired in 2010, but damage was extensive. [Near Left] Staff scrubbed decades worth of grime and dirt off of the fireplace and sealed the stonework with three coats of matte sealer, revealing the vibrant colors of the sandstone.

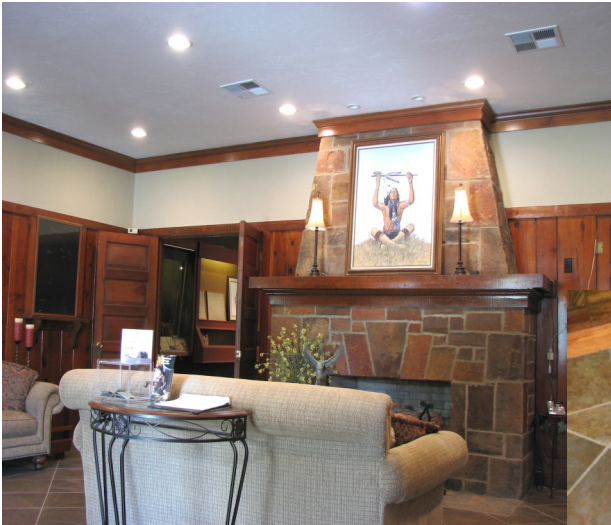
[Left] The completed entry, with restored fireplace, elevated ceilings, and new lighting. The crown molding mimics the trim on the mantel.

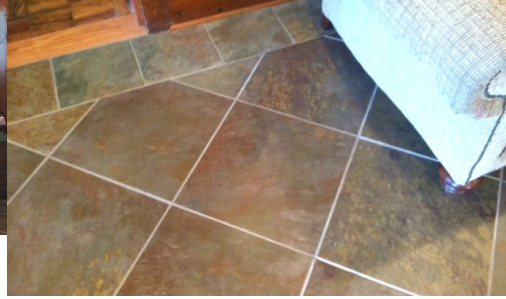
[Below] The new porcelain tile floor was set on an angle with a border to give a more sophisticated appearance. The darker colors ground the room and better complement the stonework in the fireplace.

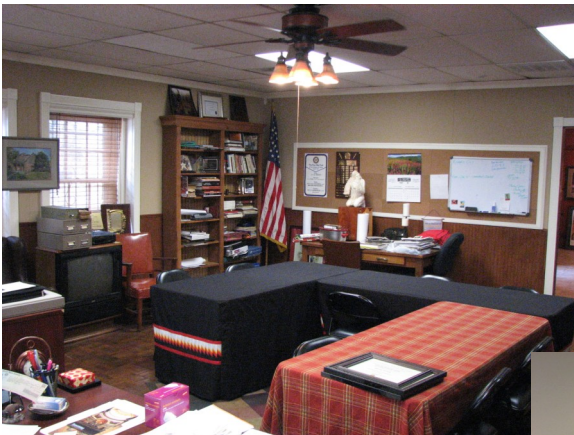
[Left] The original office space, which also serves as a public research area and meeting space, was cramped, cluttered and inefficient. Lighting was poor and works-space was limited.

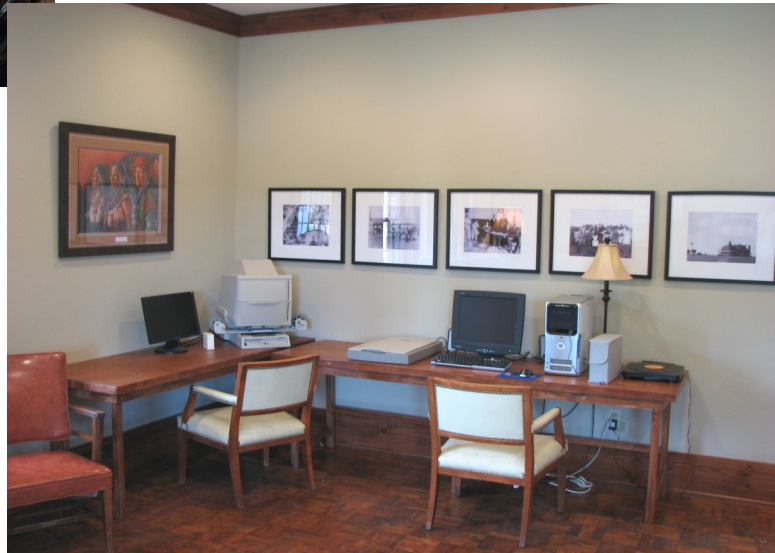
[Below] After restoration, the space features workstations for the public and staff, new electrical wiring, 20 recessed, dimable light fixtures, more free space for meetings and events, and a much more professional appearance.

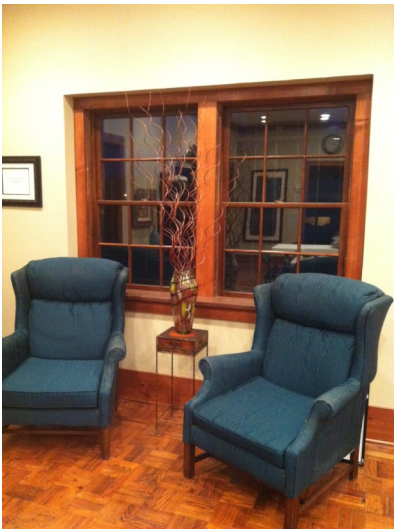
[Left] The office also highlights the new energy-efficient wood windows crafted by Wewoka Window Works. Donated and installed by Dennis Myers, the windows replicate the originals in place throughout the three rooms. In addition to the windows, low-voltage lighting and new blown attic insulation have dramatically increased our energy efficiency.
