Architectural Improvements and Facility Upgrades to the Seminole Nation Museum

*Report to the Board of Directors
April 1, 2010*

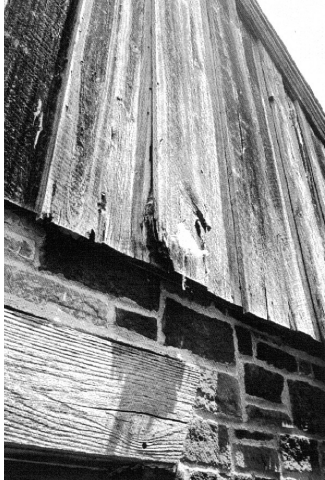
[Below left] Identified as both a “High Priority” and “High Cost” issue, the architectural assessment report indicated that replacement of the board and batten siding and fascia board was a necessity. Rotten boards were splitting and warping, allowing for birds and other pests to nest and infiltrate the building.

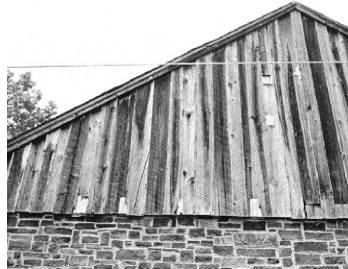
[Left] Over the years, repairs had been attempted using pieces of aluminum flashing to cover holes.

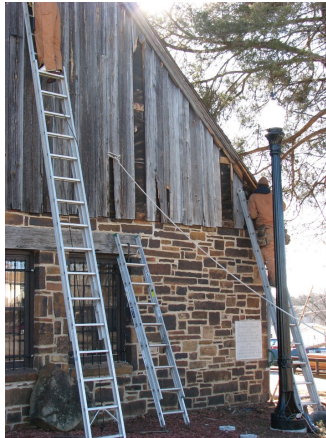
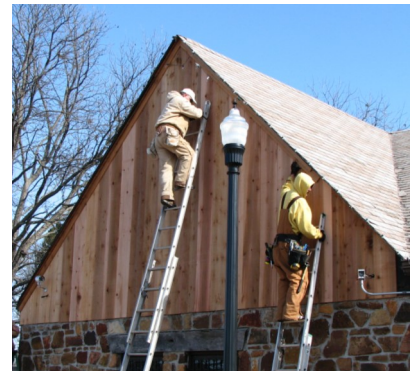
Replacement of the board and batten siding began on January 25th, 2010. As pictured near right, ropes were used to pry the existing siding from the gables. Little of the wood was salvageable as it was brittle and so rotten that it splintered upon removal.

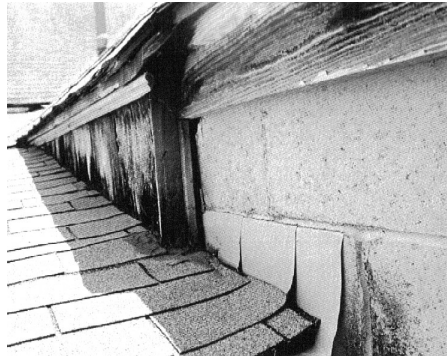
[Below right] Much of the fascia boards, especially those running on the south side along the Military Exhibit and those of the Art Gallery were in disrepair or non-existent. Over time, as the weight of rain-water and particles of the disintegrating composite roofing pulled the old guttering down, extensive damage was done to the trim.

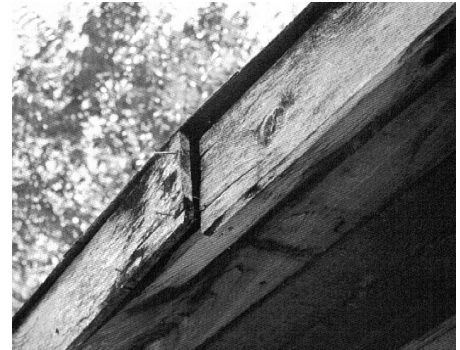
[Right] Areas where old and new portions of the building met had poor flashing and trim work, causing water to leak into the building.

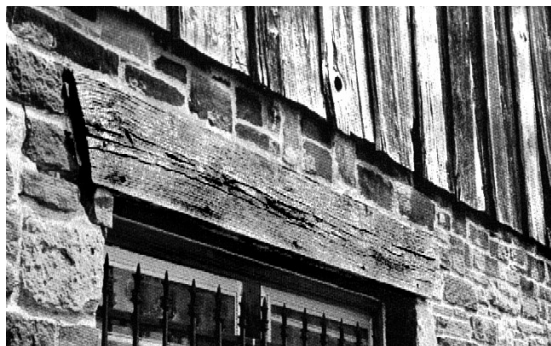
[Below left] The decorative window lintels above the four major window sets were splitting and rotting. Additionally, warping had wrested them away from the building, allowing water to permeate through gaps in the masonry. New lintels were fashioned out of 12"x3"x8' cedar and sealed in place with new mortar [Below right].

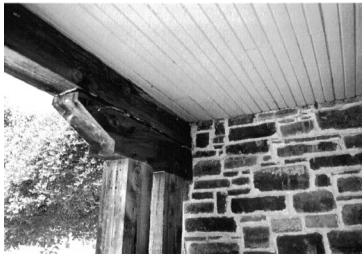
[Below left] The front porch was one of the major areas of concern as it is often the area where visitors form their first impression of the museum. Unfortunately, due to numerous issues, extensive damage had accumulated over the last several years.

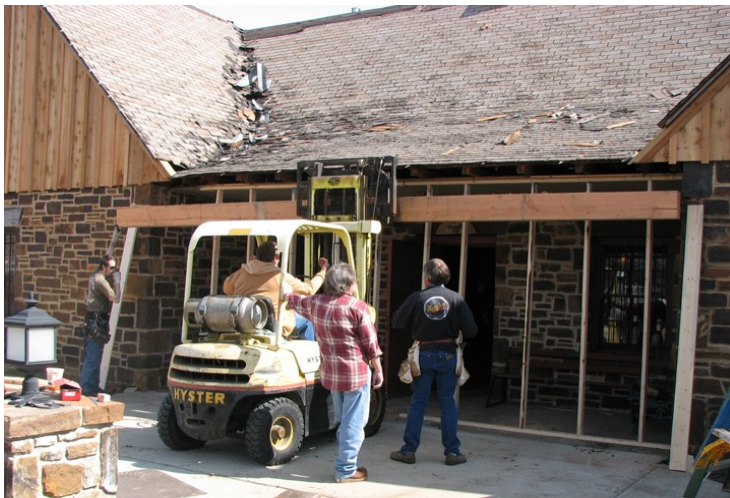
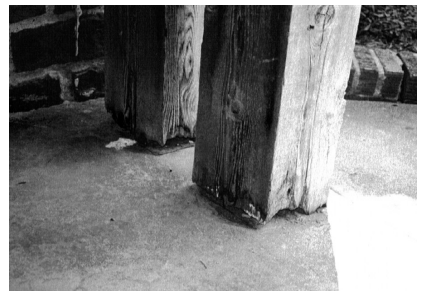
At some point in the 1980s or '90s, a minor roof leak inside the attic had been shunted over the porch area using corrugated tin. Over time, the leak worsened and the porch ceiling and support beams began to rot [Left] and [Below].

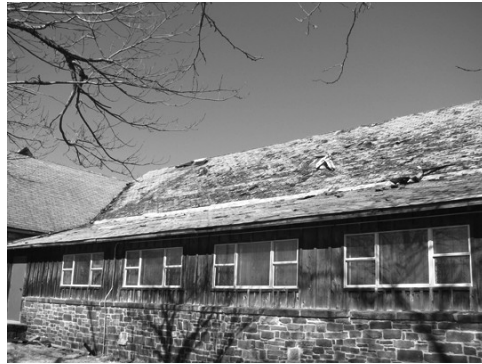
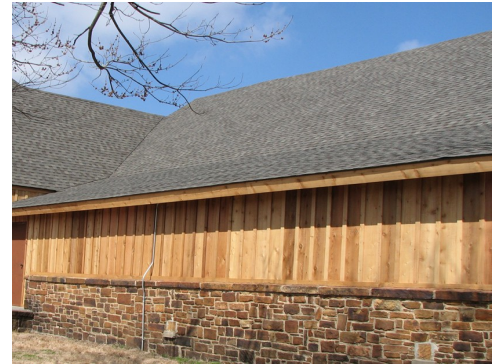
[Below left] The area on the south side that was once the gift shop had four large aluminum storm windows put in place to provide light into the room. When the space was converted into the Military Exhibit, thermal heat radiating through the windows was creating adverse issues with the new exhibits. Additionally, the windows had been vandalized and were allowing water and wind to access the room. They were also unsightly and detracted from the architectural style of the building. [Below right] The windows were removed and the exterior cedar was entirely replaced, again unifying the design with the coordinating board and batten siding.

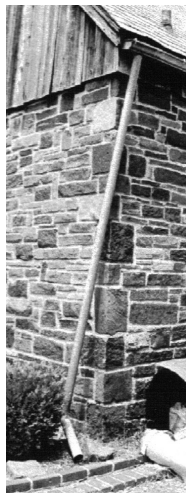
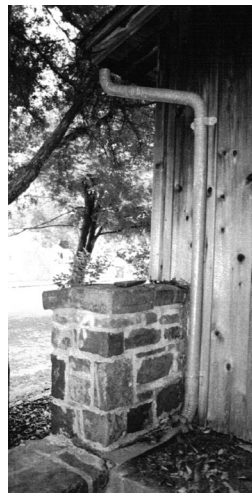
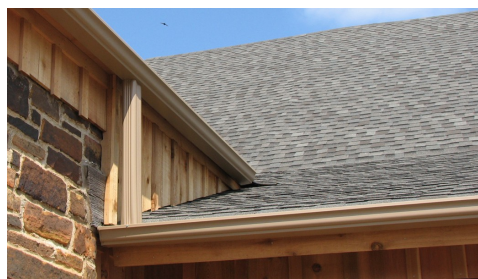
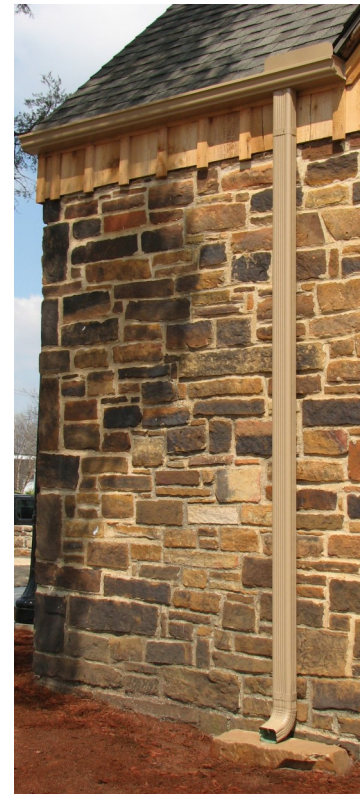
[Below three images] Significant portions of the guttering and downspouts were damaged or, as in the case of the Military Exhibit and the Art Gallery, missing altogether. The renovation replaced all existing guttering, added an additional downspout serving the front porch area and added over 150 feet of guttering to serve the Military Exhibit and Art Gallery [Right and bottom].

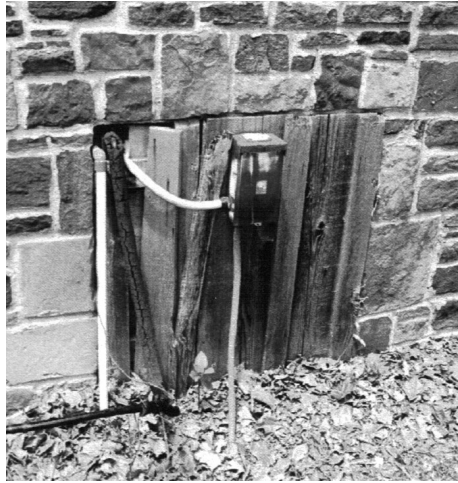
[Left] The wooden facades covering the four basement windows had rotted with time and were unsightly and falling apart. Additionally, holes drilled in the concrete blocks behind the wood to allow for the pass-through of conduit and pipe were improperly sealed and allowed for water, pests and rodents to enter the building.

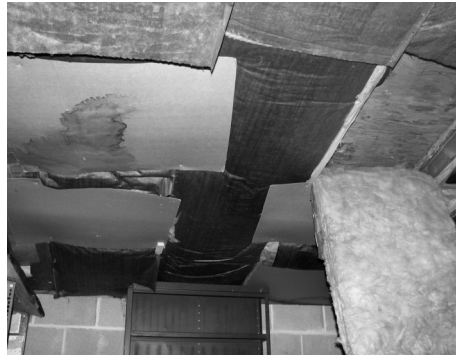
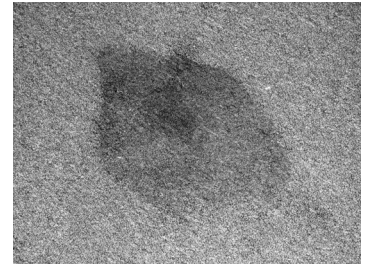
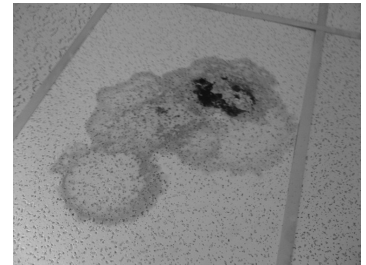
The area of greatest concern was the Art Gallery. When the addition was built in the late 1980s, the roof pitch was set to a substandard 2/12. The shallowness of the pitch caused water to stand on the roof and leak into exhibit and storage areas.

Leakage into the gallery storage area damaged the insulation in the ceiling [Above] and altered the humidity to the point that artworks had to be removed. In the exhibit space, ever-increasing leaks stained the carpet [Upper right] and discolored ceiling tiles. In some instances mold was an issue (as seen in the ceiling tile pictured [Right]).

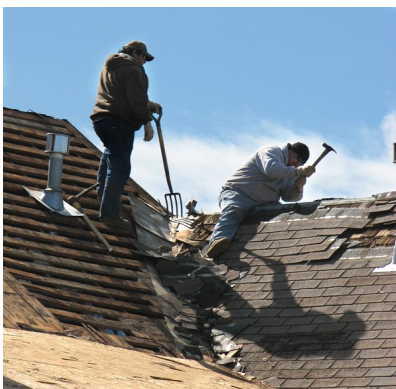
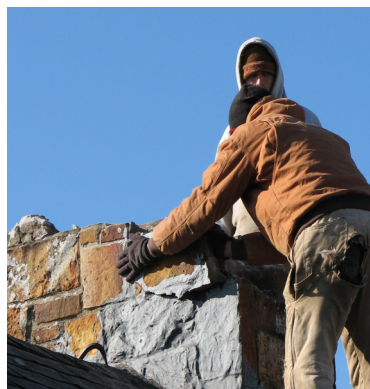
Leaks were also occurring where the stone chimney met the roofline. As the fireplaces cannot be used, it was decided to remove the stonework above the roofline and seal the area with decking and shingles. [Near left] Workers disassemble the stone chimney and roofers remove layers of old shingles in preparation for new decking [Far left].

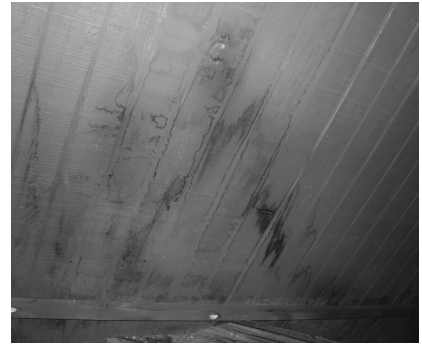
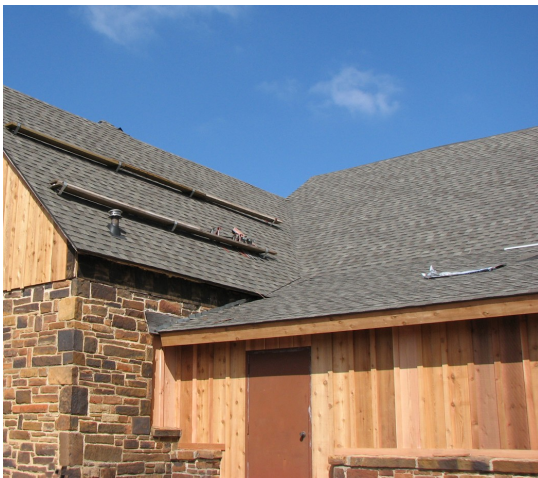
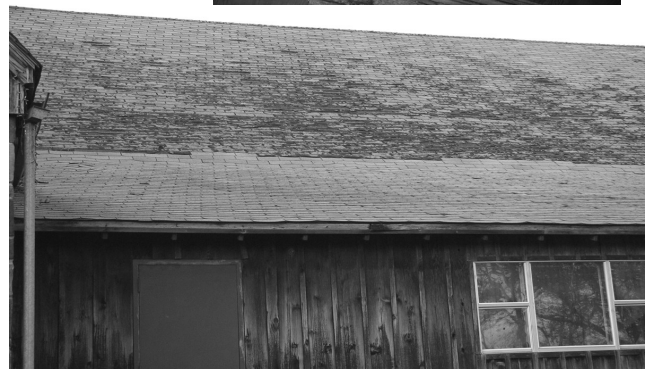
The south side of the building, which included the Military Exhibit, also had significant roof damage. Although it had been re-shingled in the 1990s, the space that was once the gift shop was aging poorly and had developed major leaks in late 2009. As can be seen in the photograph [Right], the ceiling in the Military Exhibit was becoming increasingly stained. Water infiltration required the removal of the Bill Mauldin cartoons and all of Stephen Douglas' hand-painted World War II envelopes and V-mails.

Extensive damage and missing shingles can be seen above in this image taken from the museum's south lawn. The more steeply pitched area is the Seminole exhibit, while the shallow area is the Military Room. Once completed, the area showed a marked improvement not only in appearance, but in function, as well [Left].

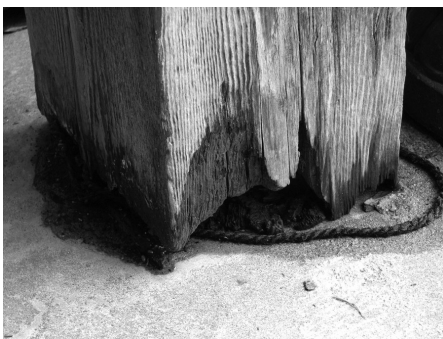
[Lower left] Severe damage to this valley above the porch caused extensive leaks to the entry area. The rotted post [Left] was the result of standing water from the leak, as well as poor drainage due to insufficient guttering.

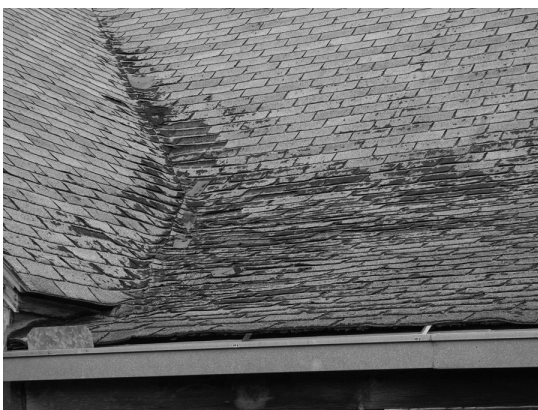
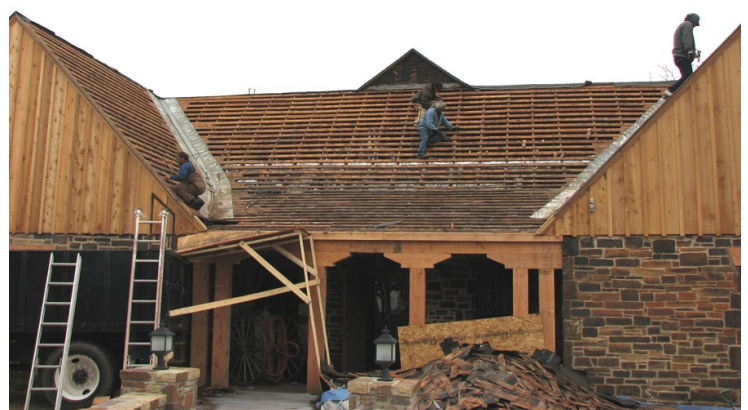
[Below right] Once the several layers of shingles had been removed—including the original wood shakes—the open network of beams and boards supporting the roof structure was revealed.

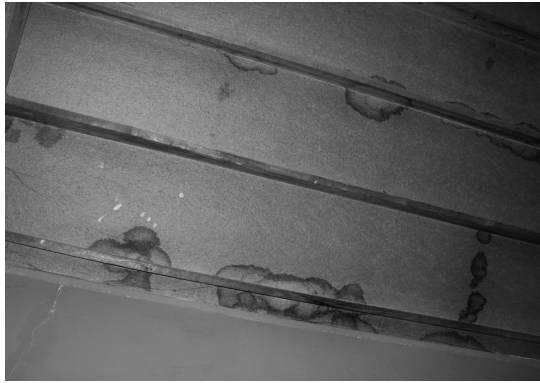
A portion of the damage to the Seminole Exhibit is shown in the photograph above. Small leaks over the past few years have mottled the large ceiling with numerous stains and discolorations. Fortunately, no artifact damage occurred.

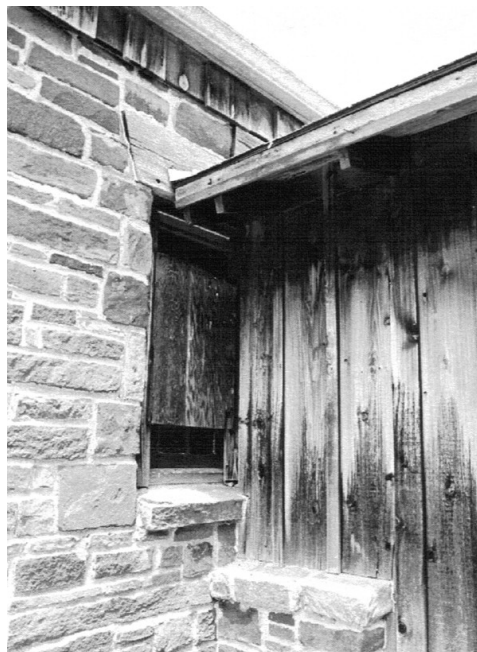
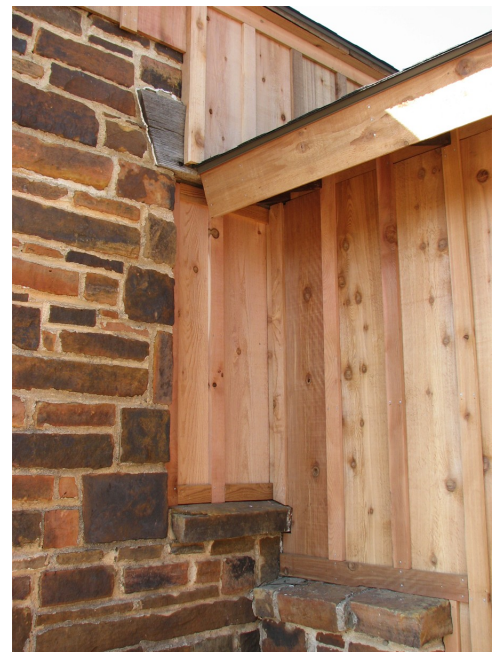
[Below left] This small window, located on the south side of the building adjacent to the Military Exhibit opens up into the men's restroom. The window was partially boarded-up in the 1970s to prevent access to the building. Despite the presence of interior wall board, wind and cold air seep through the window. Heating and cooling the adjacent interior spaces has therefore been an issue. Additionally, the exterior is unattractive and the window harbors pests. [Below right] The renovated area is much more attractive and in keeping with the over-all design of the building.
