Architectural Improvements and Facility Upgrades to the Seminole Nation Museum

*Report to the Board of Directors
April 1, 2010*

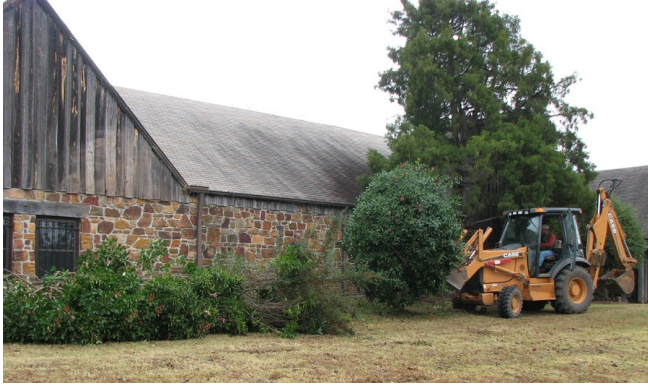
[Above] The very first work began on November 19, 2007—four days after the 2007 Holiday Bazaar. P&H Construction began removing overgrown shrubs and plantings that were hiding the building and creating problems with the foundation.

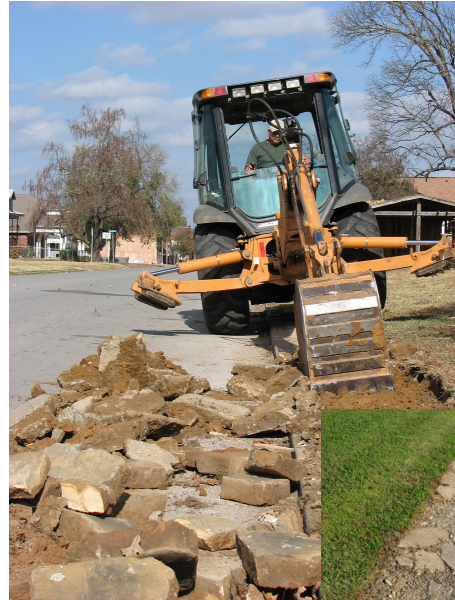
[Above] In the days following the removal of the landscaping, old sidewalks and walkways were removed.

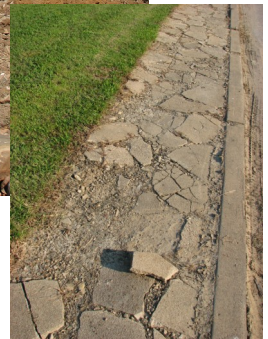
[Above right] The old sidewalks were made of busted concrete and rock and had become a trip and safety hazard. They were also too narrow and did not provide for wheelchair accessibility from the street level.
